# NOISE REDUCTION OF THE IDA-RAISINVILLE SANITARY SEWER PIPE DISTRESS

September 1989

Final Report

11. TITLE (Include Security Classification) Investigation of the Ida-Raisinville Sanitary Sewer Pipe Distress					
12. PERSONAL AUTHOR(S) Leach, R. E.; Wong, G. S.; Mitchell, G. B.					
13a. TYPE OF REPORT Final report		13b. TIME COVERED FROM _____ TO _____		14. DATE OF REPORT (Year, Month, Day) September 1989

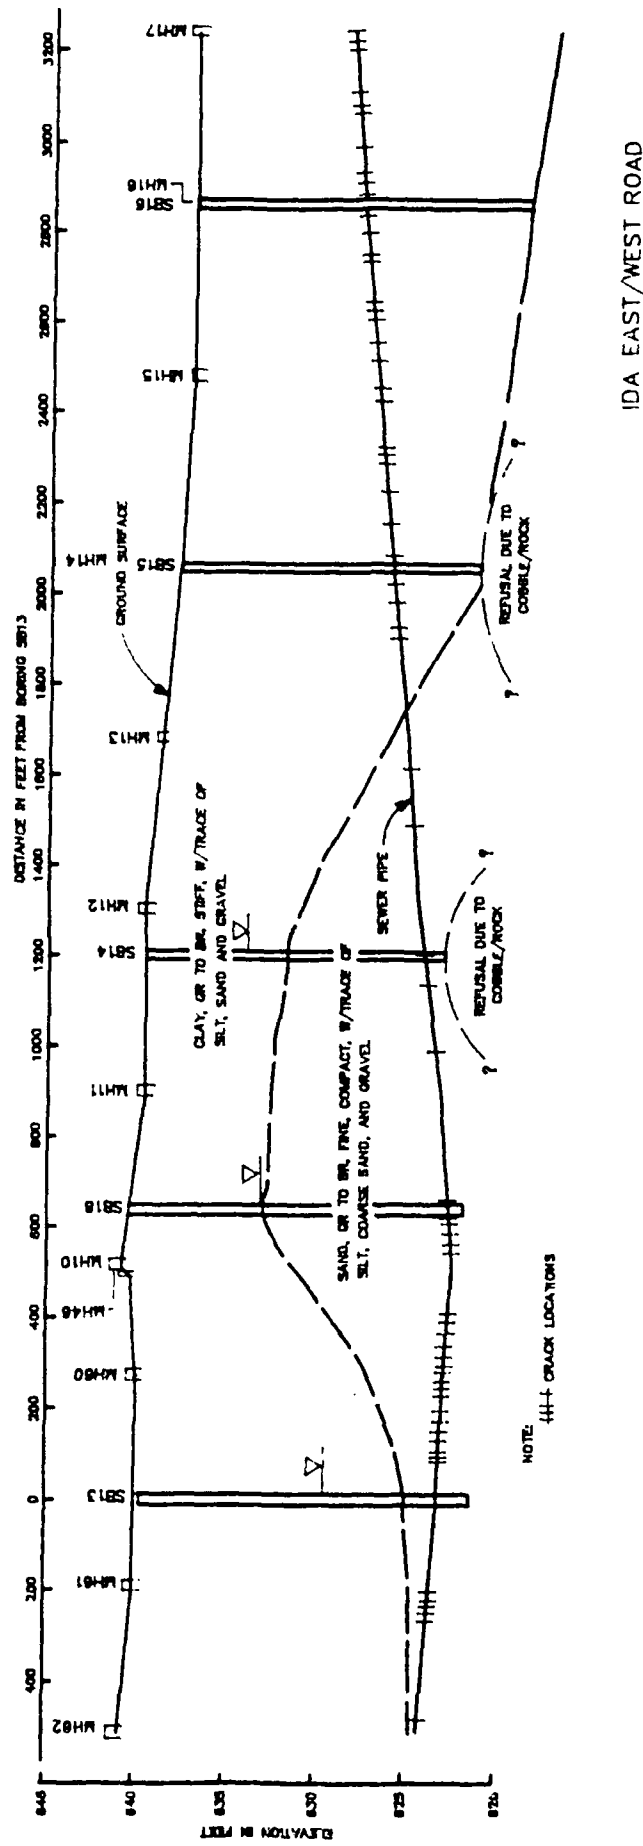
Figure 2. Soil Profile and Crack Location on Ida Road

8. As shown in Figures 2 and 3, approximately 75% of the trench bottom, where cracks occurred is located in material that is classified as fine sand with traces of silt, coarse sand, and gravel. The remainder of the trench bottom was cut into a stiff to very stiff clay with only traces of sand and silt. After excavation the bottom of the trench had the equivalent of 8 to 13 feet of head acting upwards due to the high water table. The system used to remove the water from the trench has been described to have been by pumping through pipes extending to the bottom of the trench. The construction inspector noted the contractor was pumping from a "deep well" at Manhole No. 10. If the water was simply pumped out of the bottom of the trench, there existed the possibility of a quick or unstable condition occurring in the fine sands due to the uplift pressures acting on the bottom of the trench. The clays would not become quick but could become soft if water was allowed to stand in the trench for very long. The specifications require that the area be dewatered before commencing any construction activity and that dewatering be maintained where the work area will remain in a dry condition (pg 2.01-1).

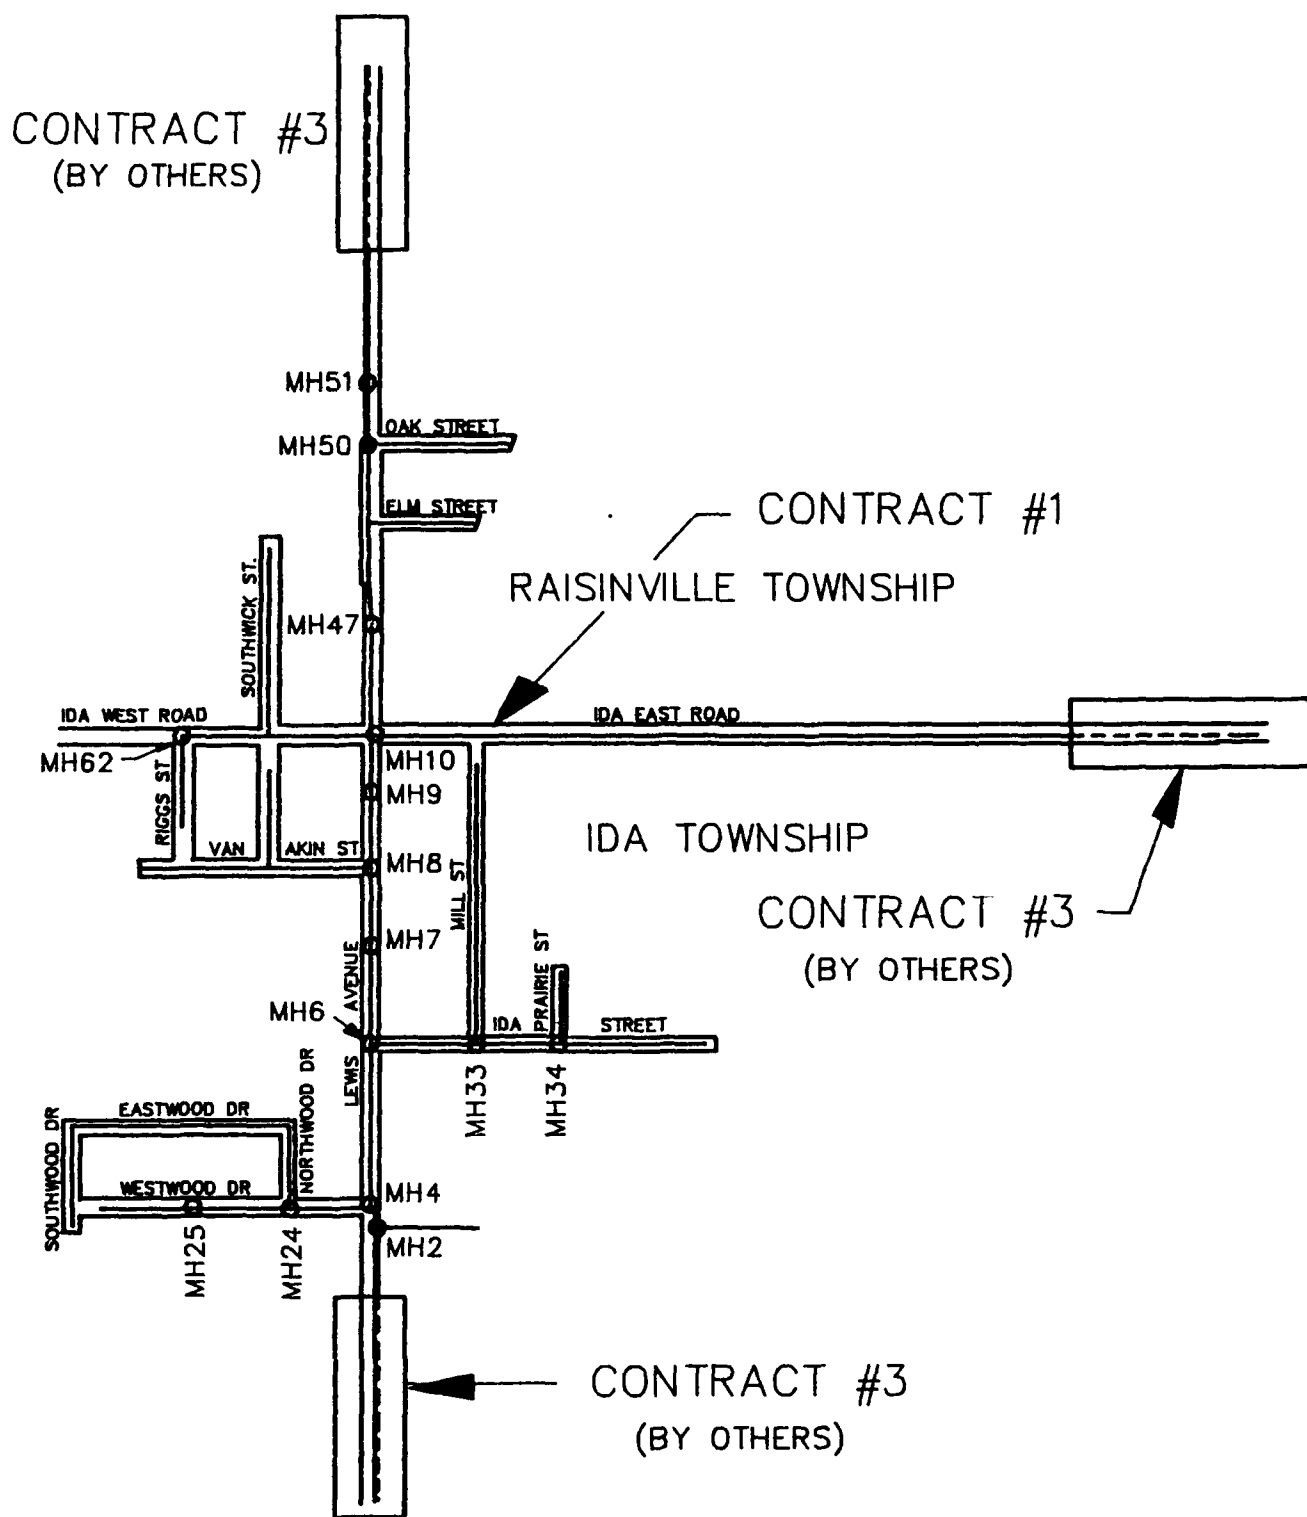
Figure 4. Site Plan Showing Manholes with Ground Water Problems

29. Soil and water conditions in the trench during construction were not ideal for pipe placement. As noted by the construction inspector there were numerous times when water was standing in the bottom of the trench when the specifications called for dewatering to dry conditions. Also unsuitable soil had to be removed in several areas and compaction of the foundation or bedding material was not attempted. These conditions and other construction procedures, i.e., attempting to obtain compaction of the backfill, shaping of the bedding stone, compaction under and around the pipe, could lead to differential settlement of the pipe. Settlement could cause expansion of existing cracks or possibly could cause new cracks. Settlement of the pipes should be complete for the construction phase but settlement of the backfill is possible, depending on the degree of compaction. If excavation and recompaction of the backfill near the pipes becomes necessary, care should be exercised to prevent further damage to the pipes.
